Rapid Airfield Damage Repair (RADR) Program

# Modified Light-Duty AM2 Capability Assessment

## **Modified Light-Duty AM2 Capability Assessment**

#### Final report

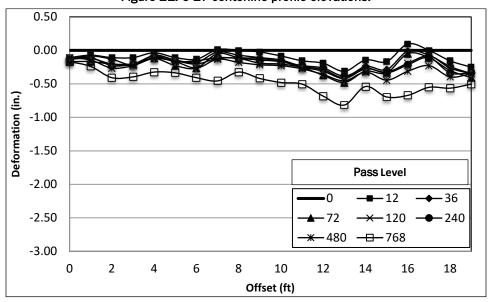
Figure 21. C-17 centerline profile elevations.

A plot of the centerline profile at different pass levels on the mat surface, as determined from robotic total station recordings, for the C-17 test item is shown in Figure 21. All of the deformation values were below the 3.0 in. failure criterion.

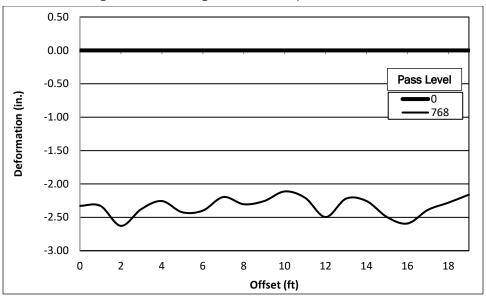
Figure 22. C-17 subgrade centerline profile elevations.

A plot of the subgrade centerline profile for the C-17 test section is shown in Figure 22. While the change in elevation values were approaching 3.0 in., the deformation values were all below 0.5 in.

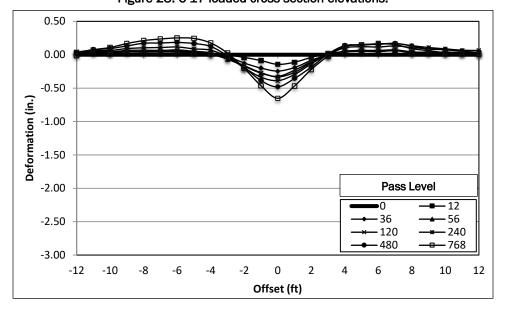
Figure 23. C-17 loaded cross-section elevations.

The elevations of the loaded, unloaded, and subgrade cross sections were collected along the three cross sections for the C-17 test item. The deformation values of each of the three cross sections were averaged for each data set and displayed in Figures 23, 24, and 25, respectively. All of the cross-section permanent deformation values were below the 3.0 in. criterion.

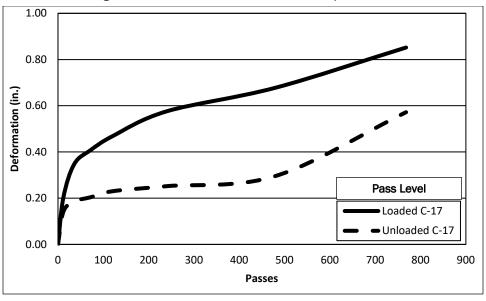
Figure 26. C-17 maximum deformation vs. pass level.

Figure 26 displays the average maximum permanent deformation data from the loaded and unloaded cross sections. Maximum deformation values were determined as the difference in elevation between the average heights of the elevated material on each side of the lowest point to the bottom of the trough.

The C-17 test item did not exceed the permanent deformation failure criterion of 3.0 in. in any type of measurement. The maximum deformation on top of the mat surface measured 0.85 in. at 768 passes. Following the trend from Figure 26, it is expected that the test item would not have reached 3 in. of permanent deformation by 1,500 passes if it had not failed by mat breakage beforehand. The limited amount of deformation showed that the Modified Light-Duty AM2 was globally stiff enough to support contingency C-17 loads out to almost 800 passes, even with the accumulated mat damage.

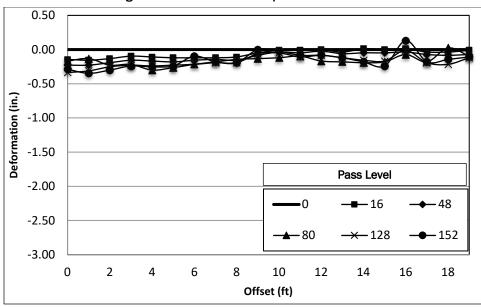
Figure 27. F-15E centerline profile elevations.

A plot of the centerline profile on the mat surface, as determined from robotic total station recordings, for the F-15E test item is shown in Figure 27. None of the deformation values were above the 1.25 in. failure criterion.

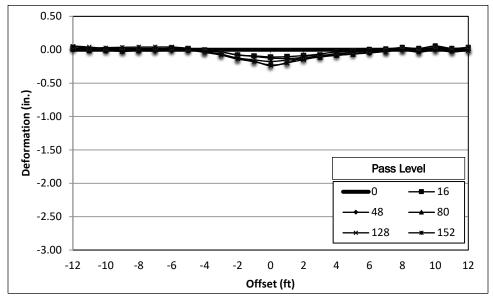
Figure 31. F-15E subgrade cross-section elevations.

The loaded, unloaded, and subgrade cross-section elevations collected along the three cross sections for the F-15E test item were averaged and are displayed in Figures 29, 30, and 31, respectively. In Figure 31, the subgrade cross-section deformation measured 1.17 in., which was close to the failure criterion; however, it was still within the allowable limits.

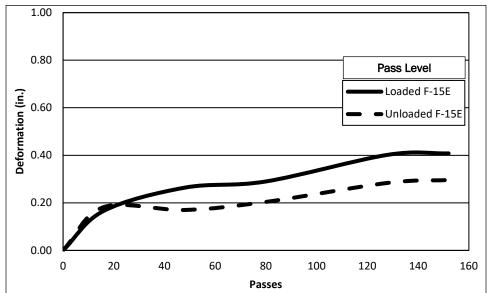
Figure 32. F-15E maximum deformation vs. pass level.

Figure 32 displays the average maximum deformation data from the loaded and unloaded cross sections. Maximum deformation values were determined as the difference in elevation between the average heights of the elevated material on each side of the lowest point in the bottom of the trough.

The F-15E test item did not exceed the permanent deformation failure criterion of 1.25 in. in any type of measurement. The measured maximum deformation on the mat surface was 0.41 in. at 152 passes. The maximum deformation on the subgrade measured 1.17 in. Based on the trend in Figure 32 and the elevations shown in Figure 31, the F-15E test item would have failed by rutting before reaching the 1,500 pass requirement. One reason that the deformation was greater with respect to its failure requirement for the F-15E test item was that the overlap/underlap connectors sheared off quickly, causing the deformation directly under the centerline to grow more quickly than the overall mat system would typically allow. The core of the mat deformed less rapidly than the overlap/underlap connector.
